Travertine Voids

This handout was developed as a reference tool for the Basics of Travertine, Fabrication, Selection, Applications, & Maintenance presentation as developed by Natural Stone Institute's Education Committee. www.naturalstoneinstitute.org/ceu

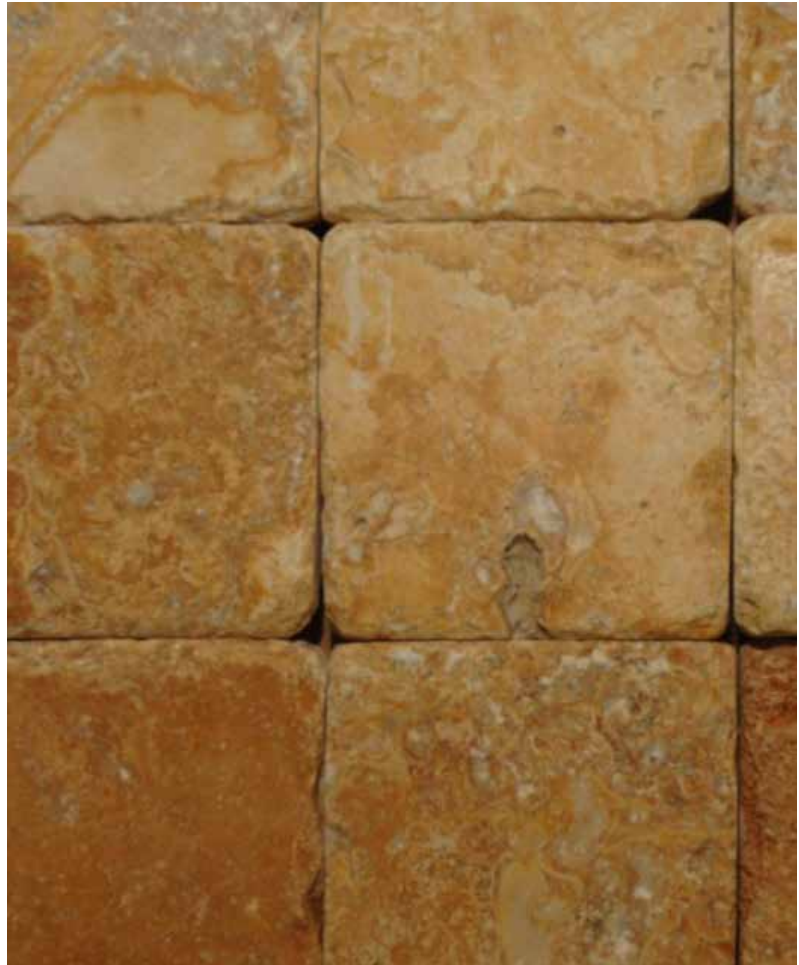
One could argue that this material selection wasn't perhaps the most appropriate for this application, although there are certainly a great number of travertine floors in hotels. The Natural Stone Institute's Dimension Stone Manual documents this behavior of travertine, and also clarifies that it is both acceptable and common practice to fill these voids in place as they become visible. Once the floor has been in service longer, most of the barely subsurface voids will have been exposed, and the discovery of newly formed holes will be reduced. It is akin to a "break-in" period for a travertine floor.
